Technical Evaluation of the Gold King Mine Incident

San Juan County, Colorado

U.S. Department of the Interior
Bureau of Reclamation
Technical Service Center
Denver, Colorado

October 2015

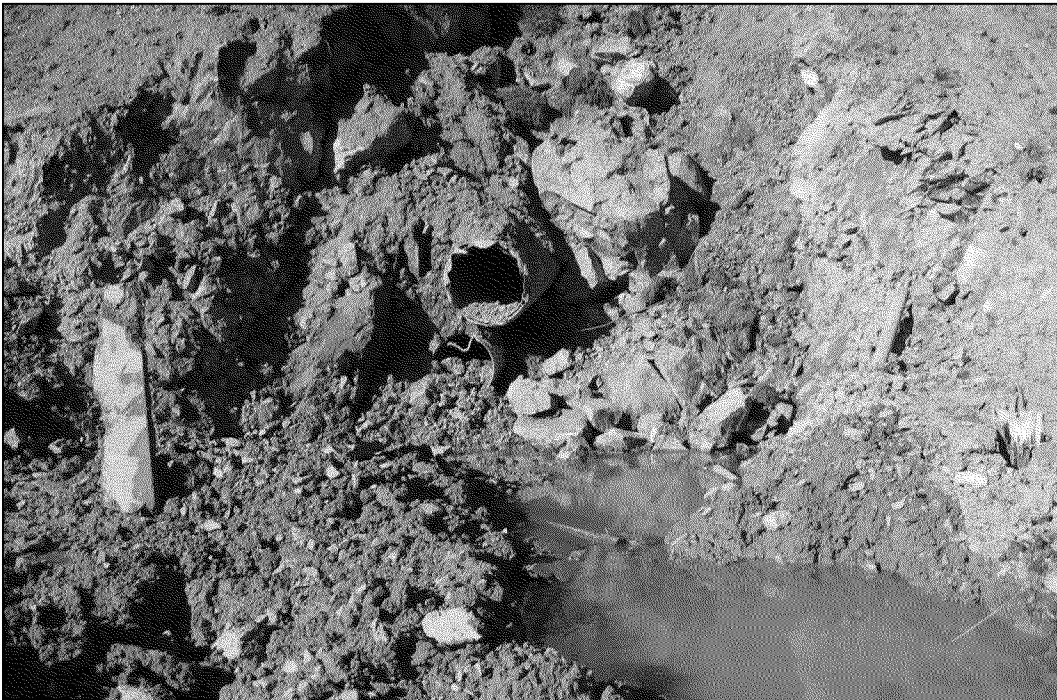
On September 11, 2014, excavations were performed to remove the metal grating and portions of the two pipes installed in 2009. As the excavation progressed down through the fill, seepage appeared (figures 25 through 27). The work stopped when EPA, DRMS, and others observed that in addition to the seepage from the base of the fill, additional seepage was now flowing from higher up on the face of the backfill. Because the excavation had a lip, the seepage ponded at a level equivalent in elevation to about 4 feet below the top of the adit. It was reportedly concluded by those onsite that there was 6 feet of water impounded in the mine (Way, 2014b). A small settling pond was installed at the base of the waste-rock dump to remove sediment from the mine water. The pond was not large enough to treat and settle what was believed to be 6 feet of impounded water. Therefore, the project was put on hold until the following year.

Figure 26.—Photograph showing the excavation of the Gold King Mine New Adit portal on September 11, 2014, taken shortly after the photograph in figure 23 (photograph from EPA project files).

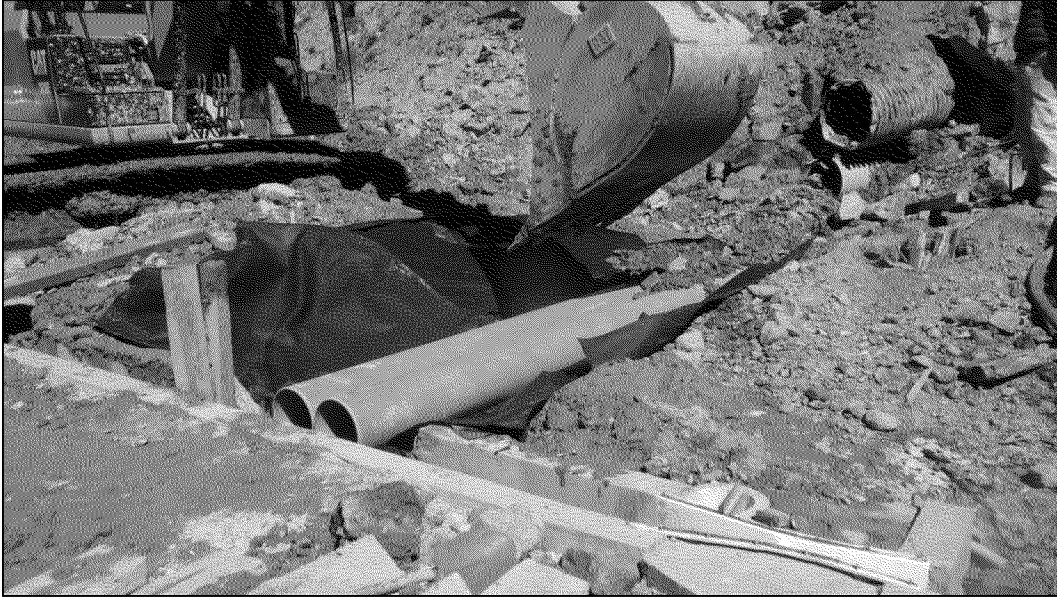
Because they had torn out most of the drain and observation pipes installed by DRMS in 2009, EPA decided to install two new drain pipes surrounded by gravel and a geotextile as a temporary measure. The new pipes were laid at a different angle than the 2009 installation. The side of the concrete trough had to be cut open to accommodate the new drain pipes (figure 28).

Figure 28.—Photograph taken on September 11, 2014, showing the installation of two new 2-foot-diameter drainage pipes. An entrance slot has been cut into the concrete trough for the pipes to discharge into (photograph from EPA project files).

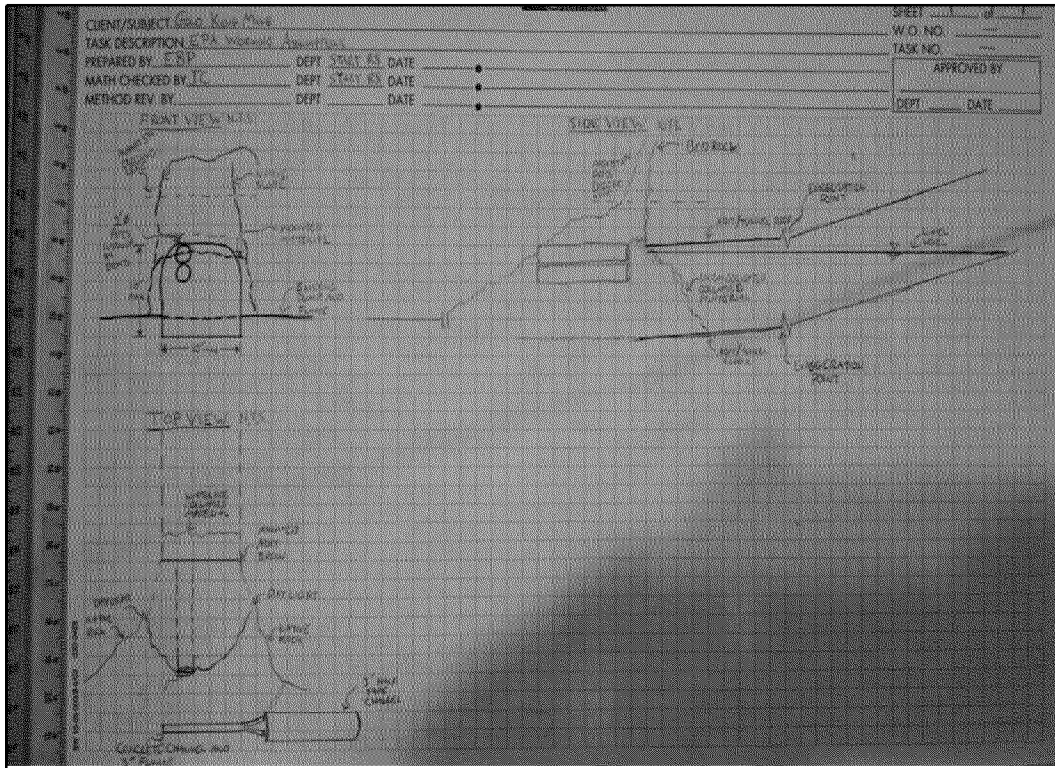
Figure 39 shows a sketch of the plan to open the Gold King Mine Level 7 New Adit portal. To provide a margin of safety, the plan assumes the water was more than 5 feet deep on the upstream side of the blockage, but still below the adit roof.

Figure 39.—Photograph showing the sketch used by EPA to illustrate the conditions at the Gold King Mine Level 7 New Adit portal (photograph from EPA project files).
